Robert Ashton House (Carey House)
North side of Road 418, approximately .2 mile
west of intersection with Route 2
Port Penn Vicinity
St. Georges Hundred
New Castle County
Delaware

HABS No. DE-240

ARCHITECTURAL DATA FORM

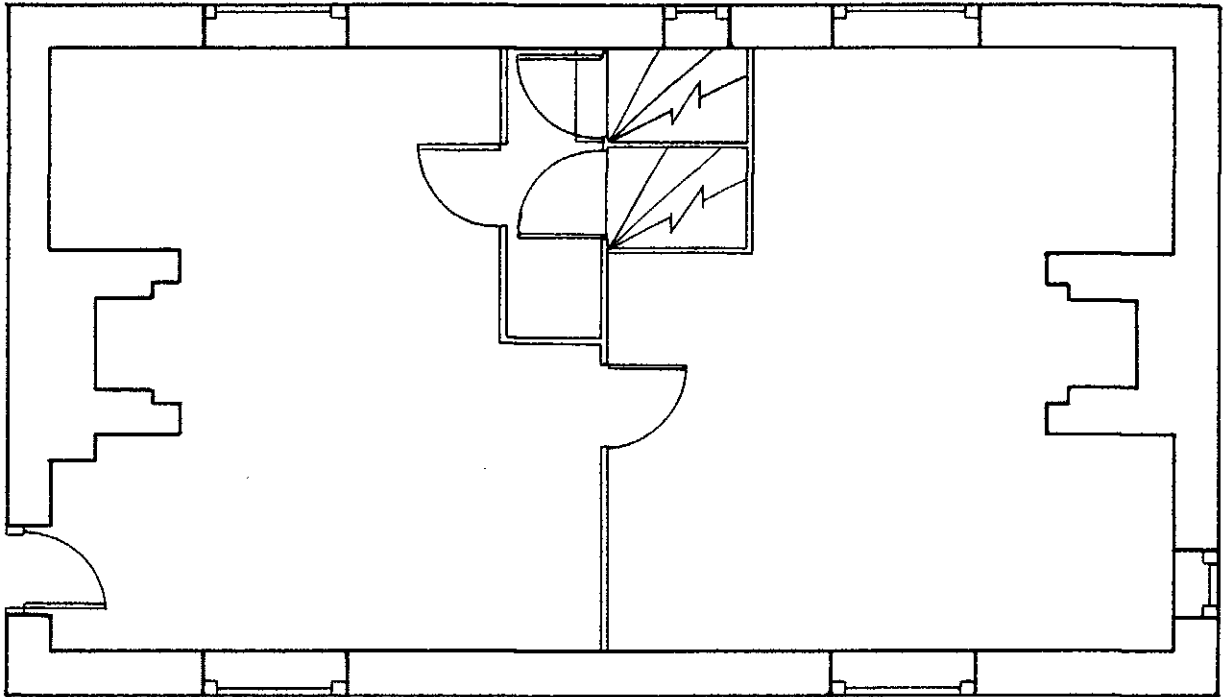
Second
Floor (reconstructed plan)

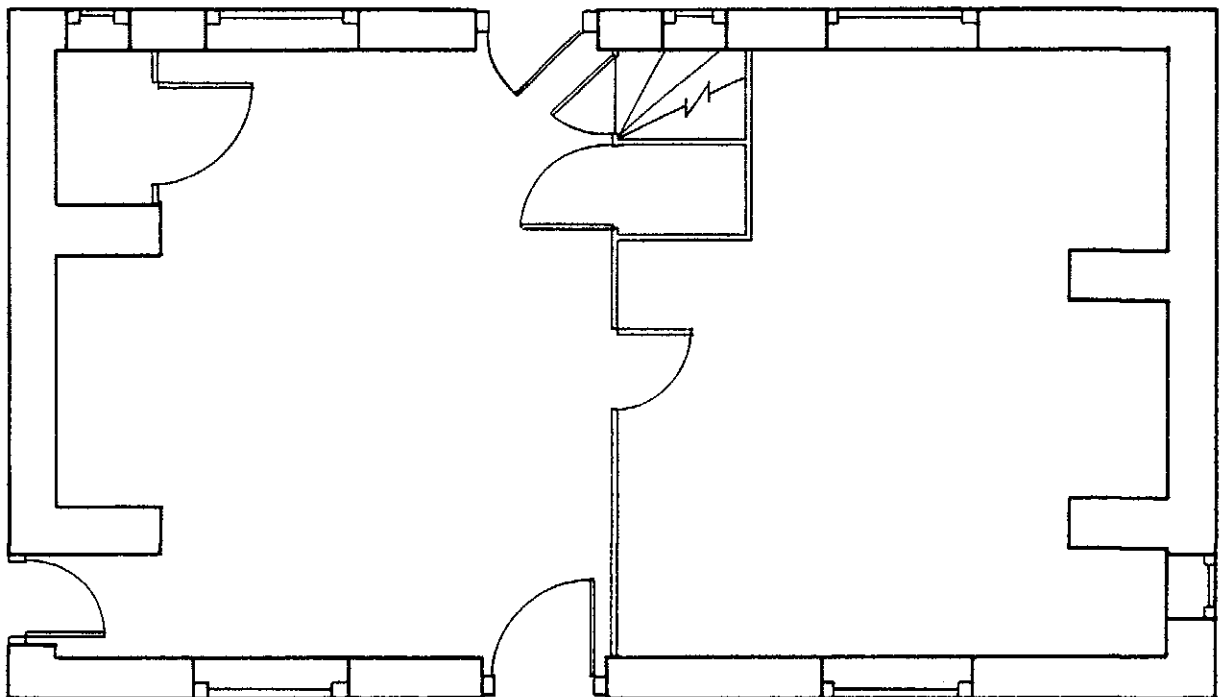
First
Floor (reconstructed plan)
